Gunpowder Creek Watershed Hydromodification Report

Gunpowder Watershed Initiative Steering Committee
March 21, 2013

Gunpowder Creek Watershed Initiative

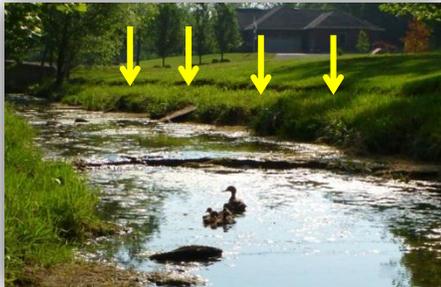
Tension crack bank failure along the entire length of the bank in the South Fork subwatershed at monitoring site SFG 5.3-UNT 0.1.

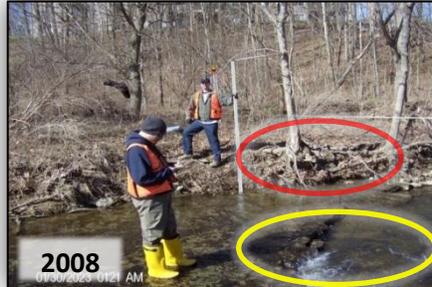
Also in the South Fork subwatershed (site SFG 5.3-DS), the erosive flow regime has caused the banks to enlarge, particularly the left bank, which has expanded more than 3 feet, resulting in the loss of two trees (red). It has also caused bedrock incision as the stream bed continues to deepen (yellow).

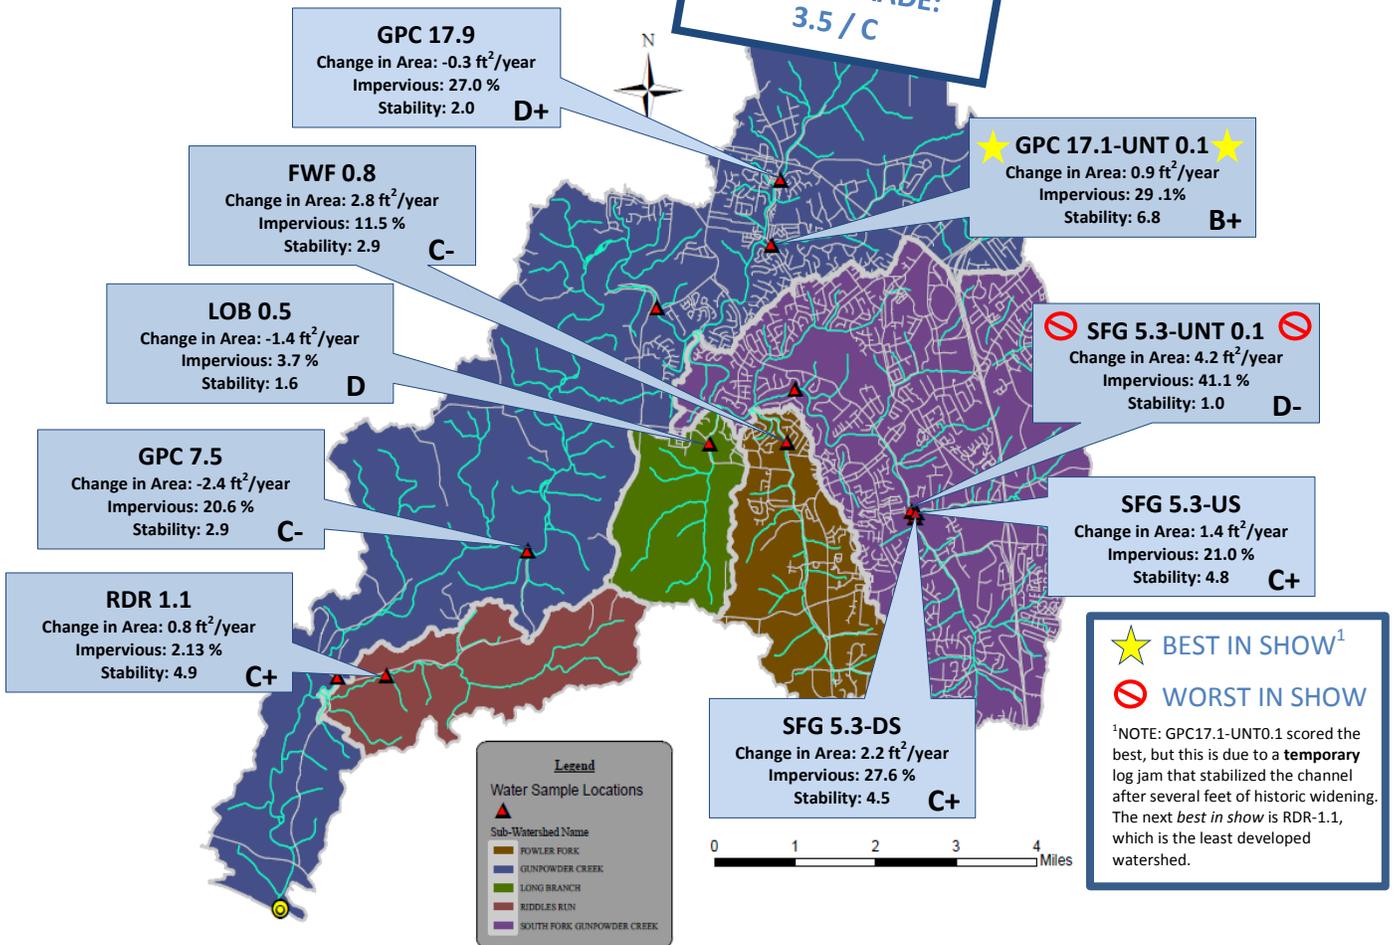
GUNPOWDER CREEK WATERSHED HYDROMODIFICATION SUMMARY

OVERALL STABILITY SCORE/GRADE: 3.5 / C
