Woolper Creek Watershed Hydromodification Report

Woolper Watershed Initiative Steering Committee
January 30, 2014

Woolper Creek Watershed Initiative

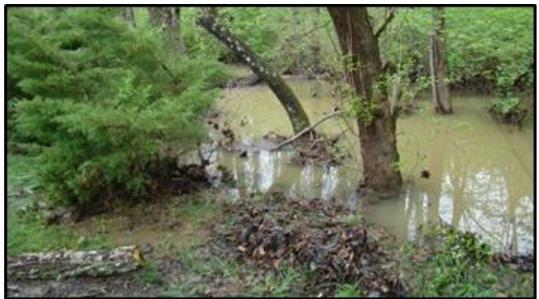
Figure 5 – Flooding along a small unnamed tributary to Woolper Creek at site WPC13.3-UNT (0.31 mi², 24% impervious). Photo by Mark Jacobs ~24 hours after a 6-month storm on April 20, 2011

The primary reason for the high rates of stream bed instability is the excess stormwater runoff that is created by watershed development and routed quickly and efficiently to the streams. As captured by flow monitoring gages, this makes the water depth in streams draining developed watersheds change much more rapidly than those draining undeveloped watersheds. For example, as measured in 15-minute increments, the water level in Double Lick Creek (1.82 mi², 3% impervious) rarely fluctuates by more than 1%: it only occurs ~3% of the time (Figure 4). That is, for about 97% of the time, water levels in Double Lick Creek are extremely stable. In contrast, the water levels in Allen Fork at site ALF 2.7 (3.59 mi², 21% impervious) change by more than 1% about 35% of the time. Furthermore, the water levels change by more than 10% about 4% of the time, and change by 100% about 0.2% of the time. In summary, the water levels in Allen Fork tend to change about 10 times more rapidly than the water levels in the Double Lick Creek. A similar observation can be made when analyzing the actual water depth relative to the average depth. The maximum water depth recorded in Allen Fork was about 5 times deeper than average, whereas the maximum water surface was only about 2 times deeper than average in Double Lick Creek. Deeper flows create the potential for more stream erosion and flooding. Stream erosion and flooding have been documented throughout the developed tributaries in the Woolper Creek Watershed (e.g. Figure 5); however, they are not reported to be a concern in Double Lick Creek.
