# Preliminary Middle Creek Plan (Summarized)

## Preliminary Plan

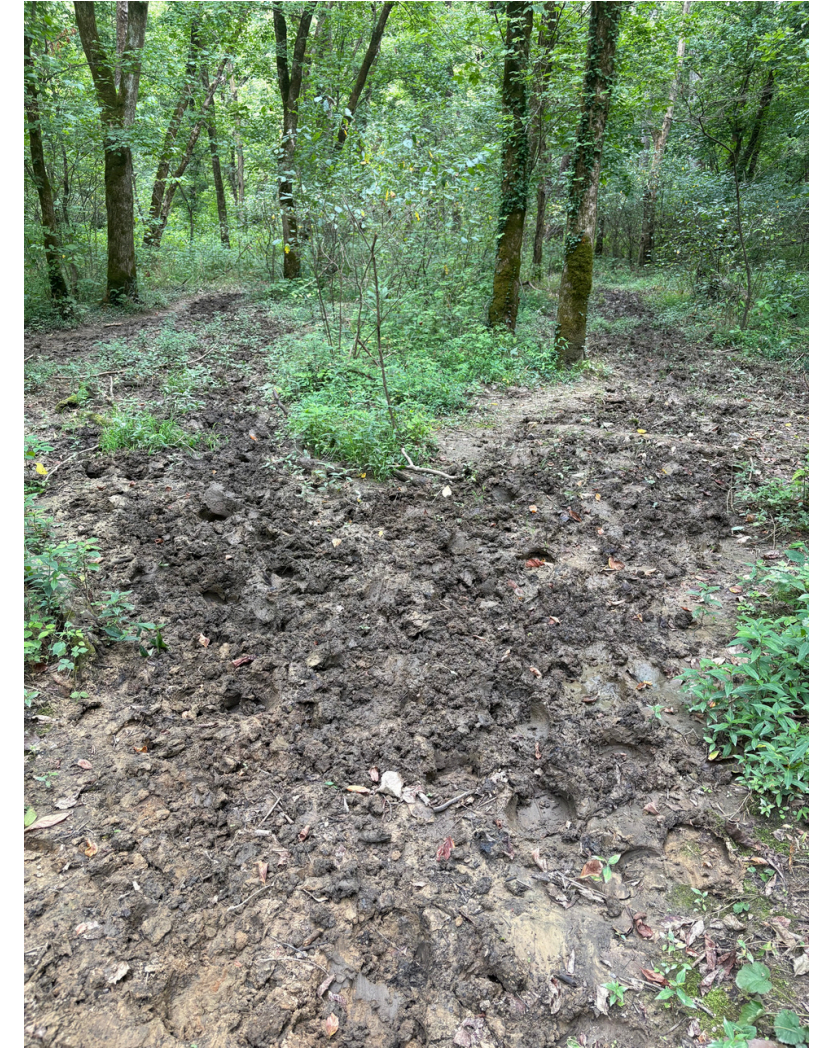
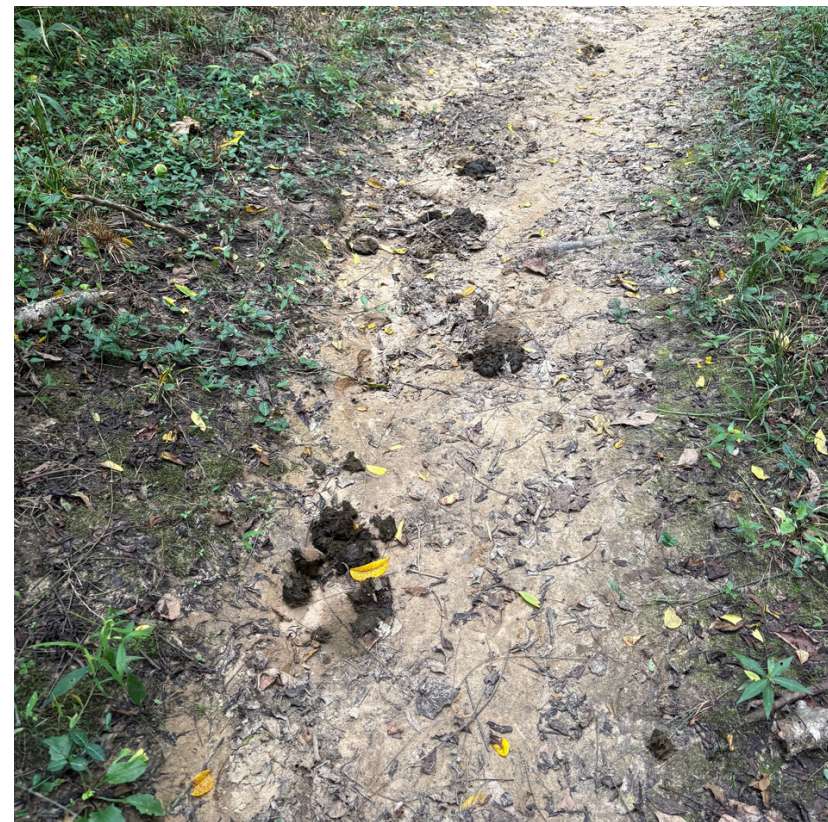
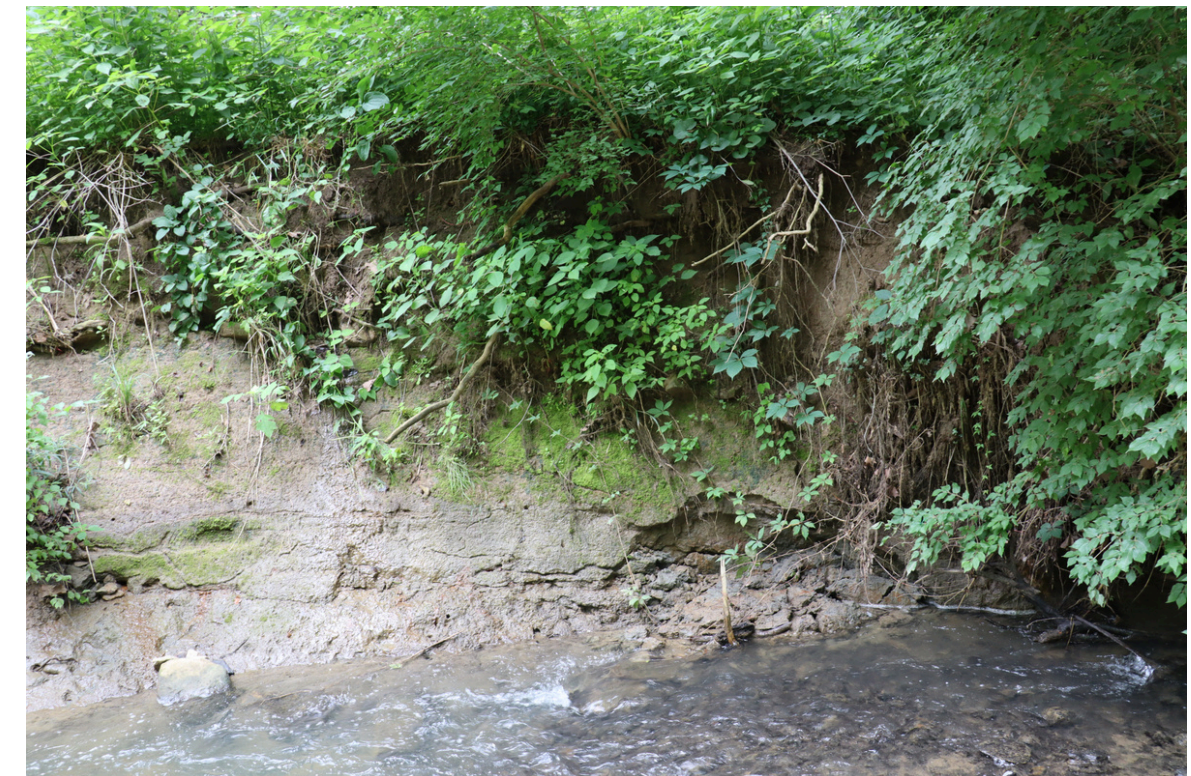
These images show the impacted trails from horses (top right), horse feces (bottom left) near the creek, and an example of the eroding bank and invasive honeysuckle growing from the top of the LDB (bottom right).

Trails at Middle Creek Park are unique from many parks in the area because they are open to horseback riders as well. While this provides a nice natural area for riders to bring their horses, the trails and nearby stream may be impacted by erosion, sedimentation and overall usability of the shared trails. Further management to protect the riparian zone and public trails may be needed.
