Gunpowder Creek Watershed Hydromodification Report

Gunpowder Watershed Initiative Steering Committee
March 21, 2013

Gunpowder Creek Watershed Initiative

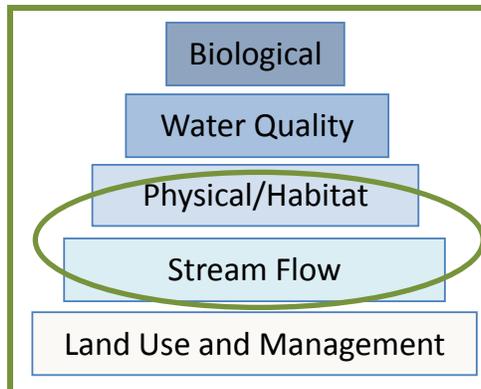
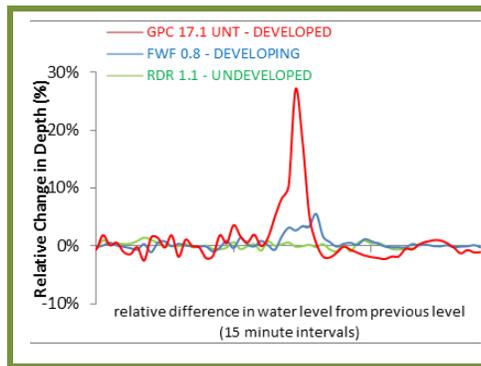
Data logger information was compared for three sites within the Gunpowder Creek Watershed that had similar drainage areas but varying levels of development. The information supports that the altered flow regime associated with conventional urban development leads to flashier and larger flows. This is demonstrated in the

chart above by comparing the most developed site (red) to the other two sites. The most developed site experienced much higher and more rapid changes in water levels during the same rain event compared to the other two data logger locations. Stability and habitat quality tend to decrease in developed watersheds and impervious area has been strongly correlated to channel enlargement, bed coarsening, shorter riffles, and deeper, longer pools in Northern Kentucky streams (Hawley *et al.*, In review).

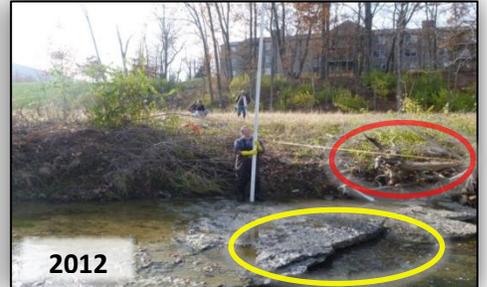
GUNPOWDER CREEK WATERSHED HYDROMODIFICATION SUMMARY

OVERALL STABILITY SCORE/GRADE: 3.5 / C
